CASE STUDY

## BY TATYANA SHINE, P.E.; AND ELIZABETH PAUL

Museums consume massive amounts of energy. From exhibit lighting to temperature control and relative humidity, their costs are much higher when compared to a similar size traditional office building.

he Gettysburg National Military Park Museum and Visitor Center houses what most Civil War enthusiasts consider to be the largest collection of civil war artifacts, including a massive historic oil painting that depicts the battle. Storing these pieces of American history requires a specific dry-bulb temperature and relative humidity level be maintained on a daily basis.

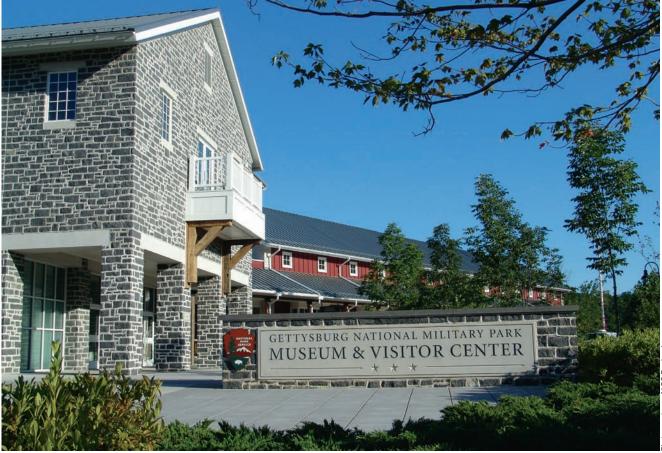
Above The museum and visitor center is designed to blend into the rural Pennsylvania countryside. It is adjacent to the battlefield, but sited at a low point in the terrain so it is not visible from the major interpretive points.

Below The facility uses more than 30 types of wall materials, including insulated metal panels, textured masonry, and stone veneer.

Type More than 30 wall types are used on this facility, including insulated metal panels, textured masonry, and stone veneer Overall R-value R-31.1 (average of all wall types) Glazing percentage 10%

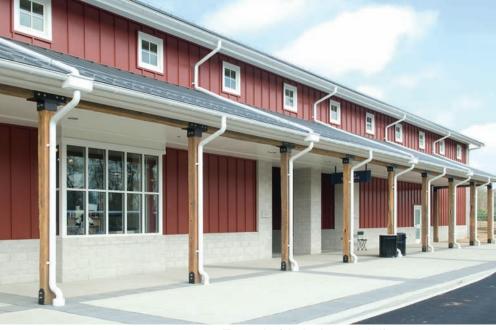
the geothermal water, and between the return chilled water loop and the geothermal water. During summer operation, if the hot water return temperature exceeds its setpoint, the twoway control valve at the condenser heat exchanger modulates open, allowing excessive heat to be rejected into the geothermal water.

adequate hot water temperature. The two-way control valve at the evaporator heat exchanger modulates open, allowing heat from the geothermal water into the return chilled water flow and then into the condenser hot water loop. The chillers' energy efficiency ratio (EER) is 30 and the heating coefficient of performance (COP) is 5.5. These are the nominal cooling and heating efficiencies, which vary with the building loads and the geothermal water temperatures.
